2006 ANNUAL SITE INSPECTION REPORT

BAILEY SUPERFUND SITE

PARSONS

July 2006

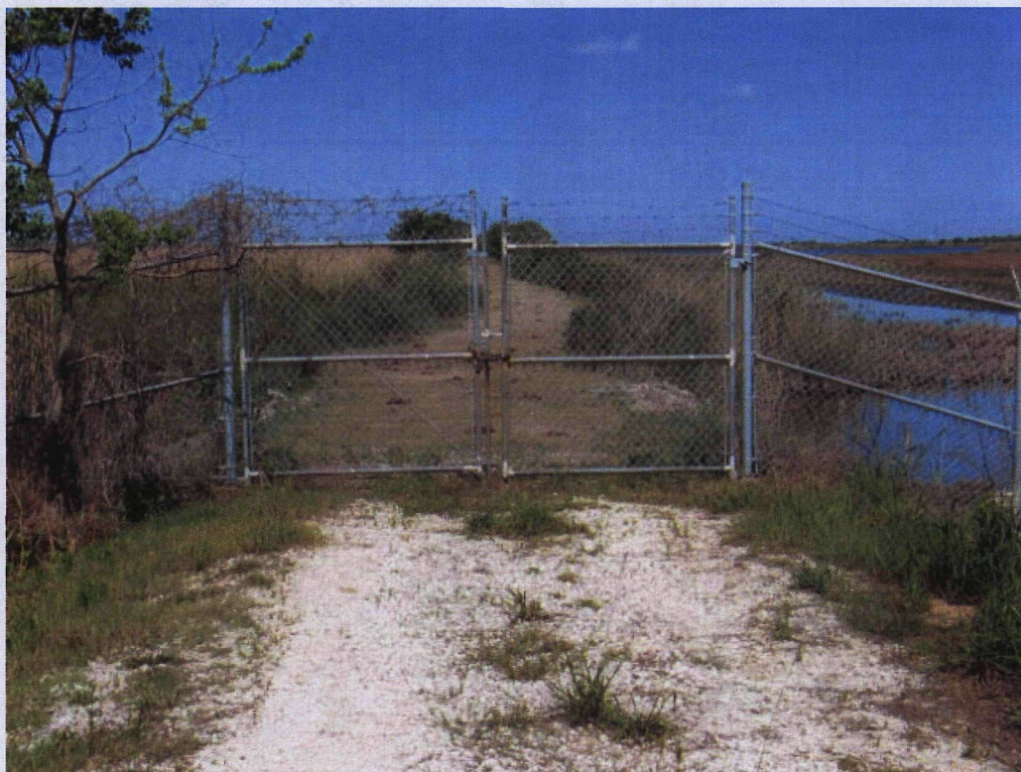
The gates and locks were also inspected and found to be in good condition. The signs located around the perimeter of the site are generally in good condition. The sign located on the back gate on the East Dike Cap is missing and needs to be replaced (Photo 1). The fencing at the site was inspected and found to be in good condition.

Photo 1 – East Dike Cap back gate looking west

- Replacing back gate signage;
- Monitoring vegetative growth on both caps during summer months to ensure that erosion is controlled;
- Continual monitoring and filling of animal burrows on both caps; and
- Seeding and fertilization with a winter rye mix in the fall.

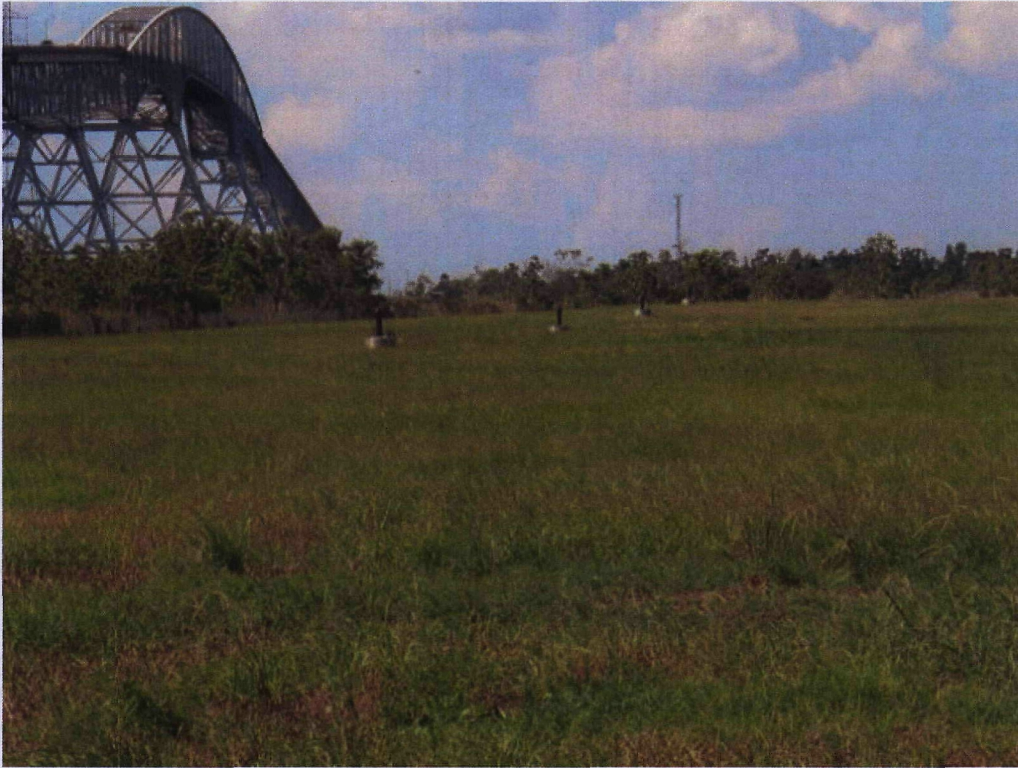
In general, the caps and dikes appear to be in good condition. Vegetative growth on the caps looked healthy and indicates that rainfall was adequate during the prior months. Photos 2-4 in Appendix B illustrate the general conditions of the two caps.

Photo 2 – East Dike Cap looking south.

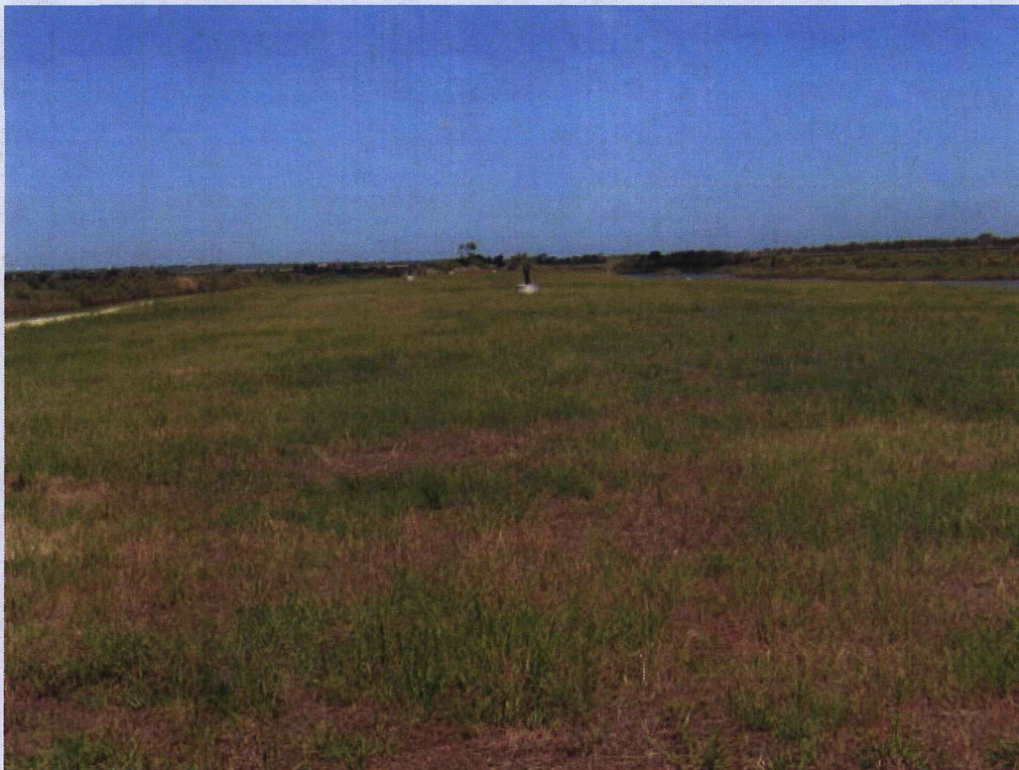
Photo 3 – North Dike Cap looking west

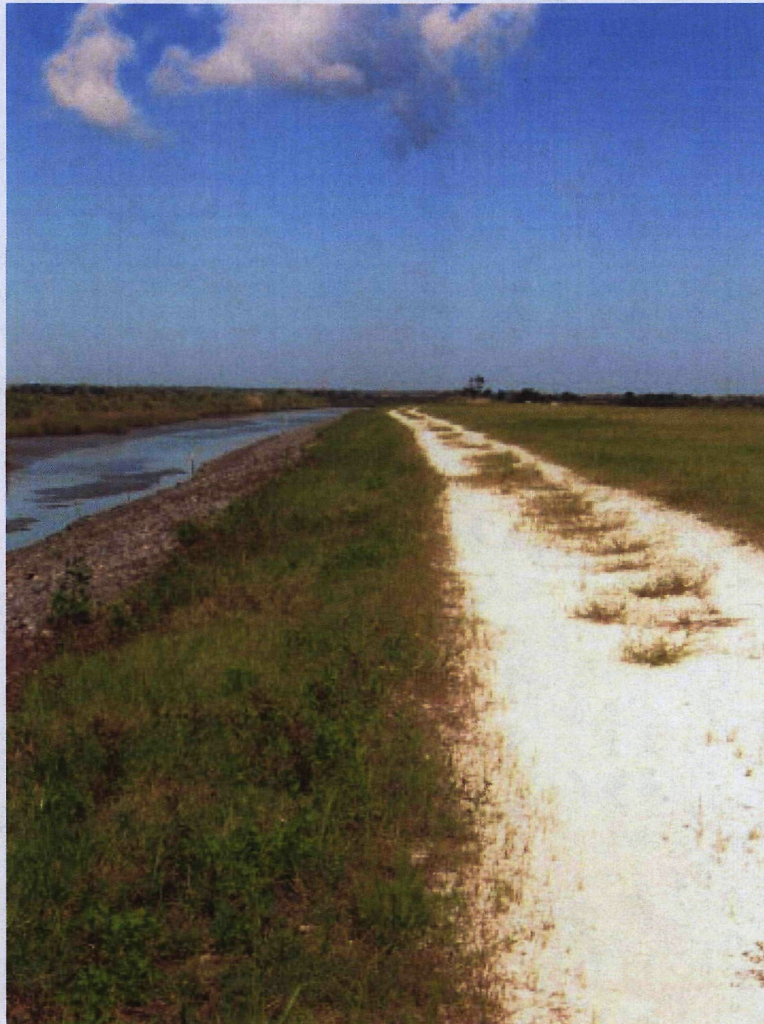
Photo 4 – North Dike Cap road looking west

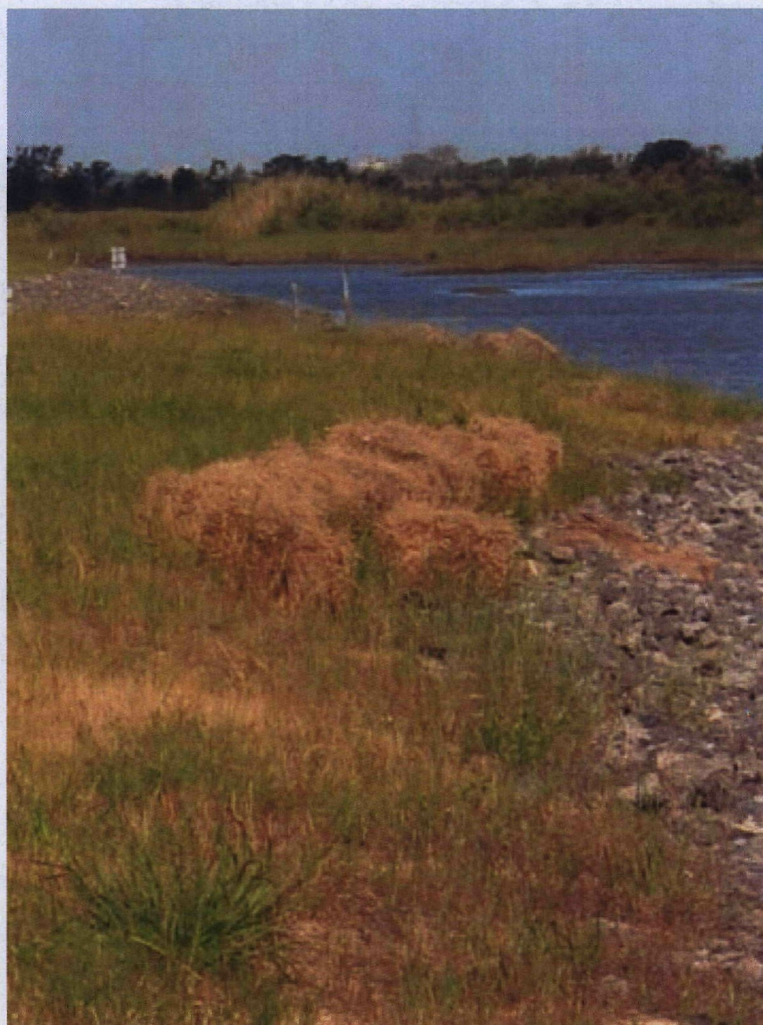
An area of approximately 300 feet along the northern edge of the North Dike Cap between the third and fifth gas vents has hay bales placed along the edge of the vegetation and rip rap as a means of erosion control (Photo 5). This method was used because the prior placement of hay bales in other areas along the dike successfully prevented further erosion and helped re-establish vegetative growth.

Photo 5 – Hay bales along rip rap on North Dike Cap

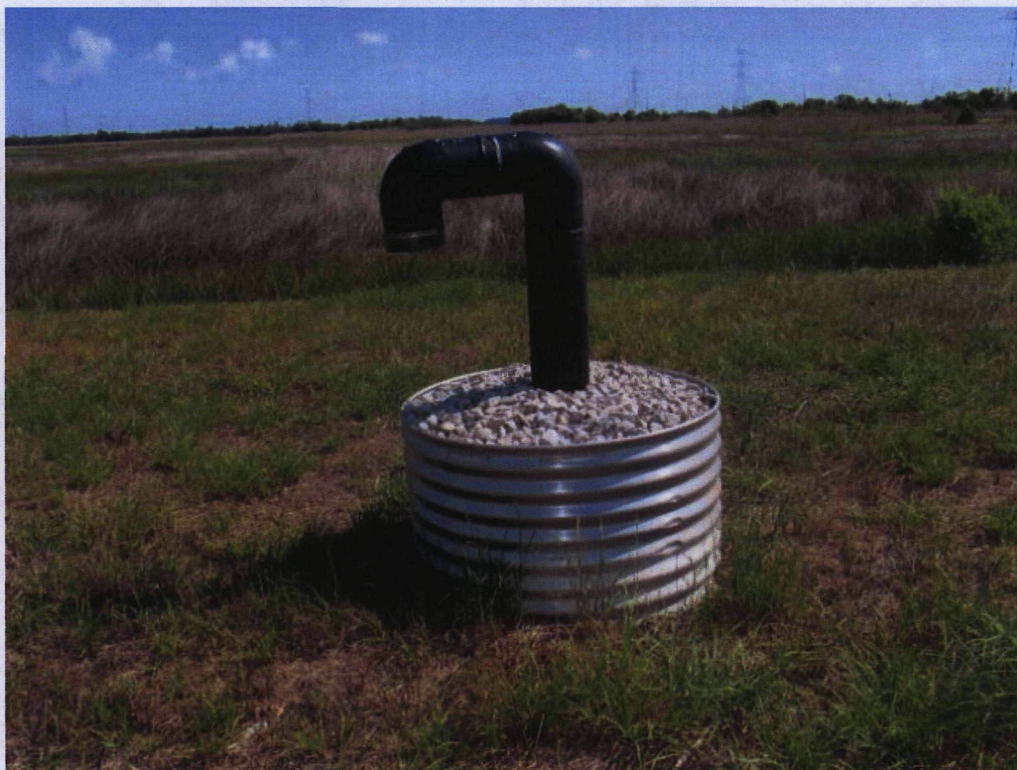
The gas vents were also inspected and found to be in good shape on both caps (Photo 6). The animal barriers installed around each gas vent on both caps effectively prevent animals from burrowing around the vents.

Photo 6 – Gas Vent on North Dike Cap

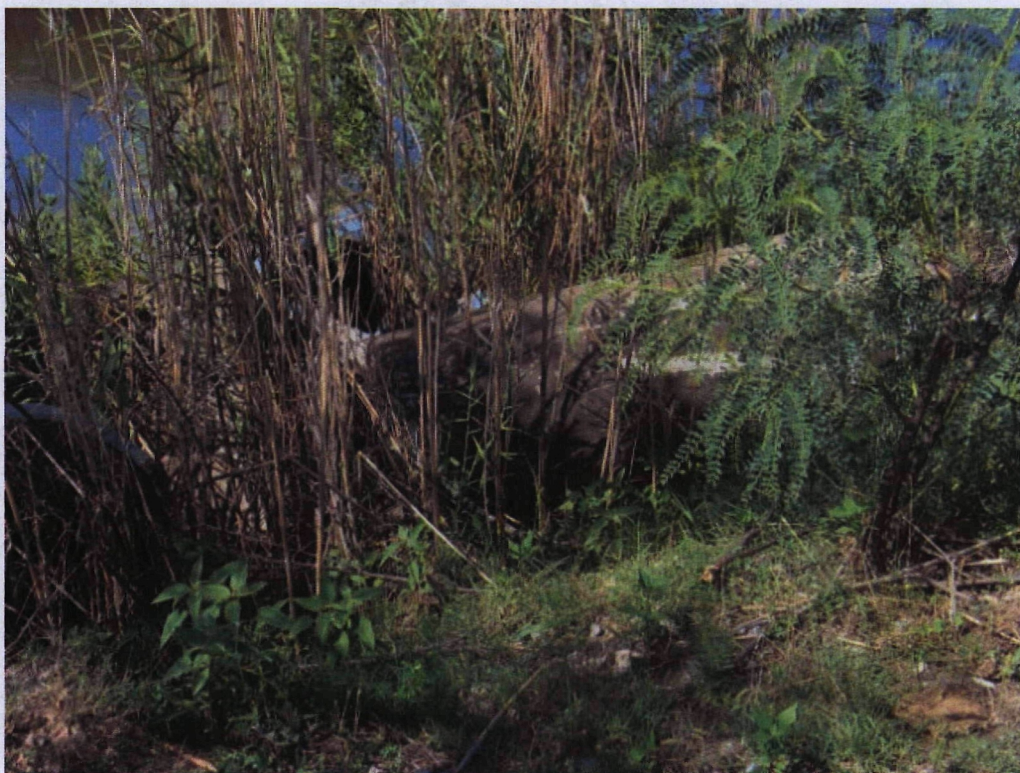
The dike breach in the North Marsh perimeter dike was inspected and found to be in good condition, allowing free flow of tidal waters. The culvert at the end of the East Dike Cap appeared to have been removed (Photos 7-9). A bent and partially demolished culvert was found on top of the ground outside the back gate and it appeared that soil had been used to fill the area where the culvert was removed. Section 2.2 of the September 1997 Final Inspection, Maintenance, and Monitoring Plan indicates that "... the breaches in the perimeter dikes will be inspected to ensure that there is free movement of water within the dike area." It appears that removal of this culvert may prevent the free movement of water. Parsons recommends that this be brought to EPA's attention so that EPA may follow up with the appropriate landowners to address this issue.

Photo 7 – Culvert laying outside of East Dike Cap back fence

Monitor Pond A - drainage flow from East Gap to confirm if culvert removal is a problem.

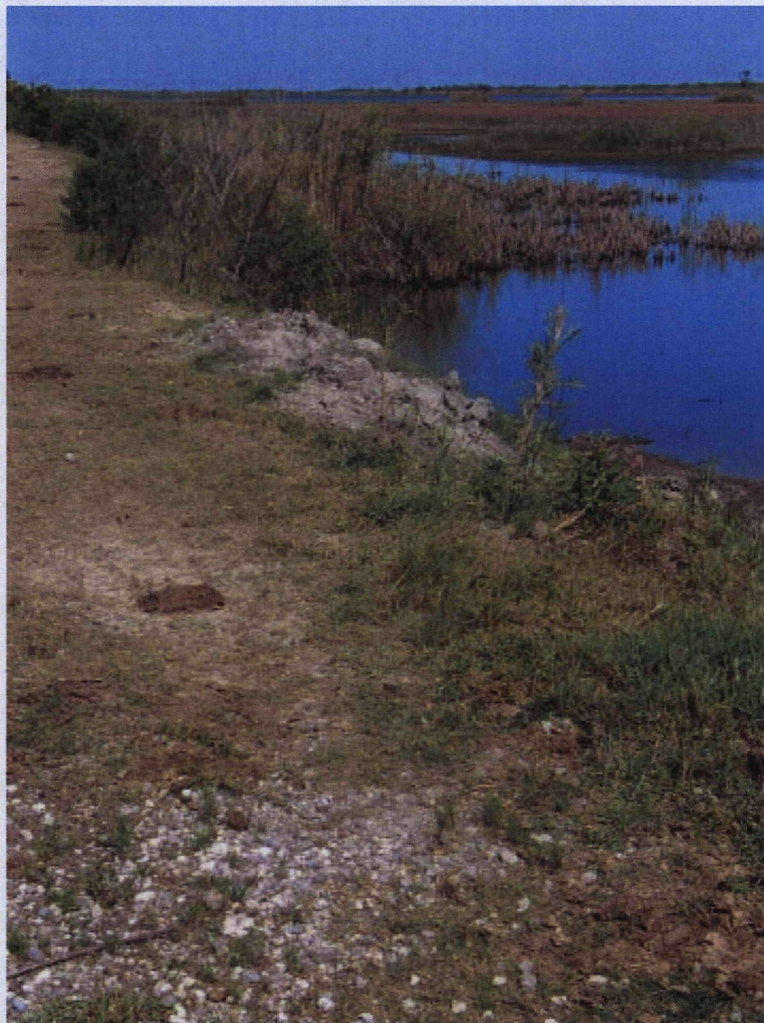
Photo 8 – New soil where culvert was removed (north side of road)

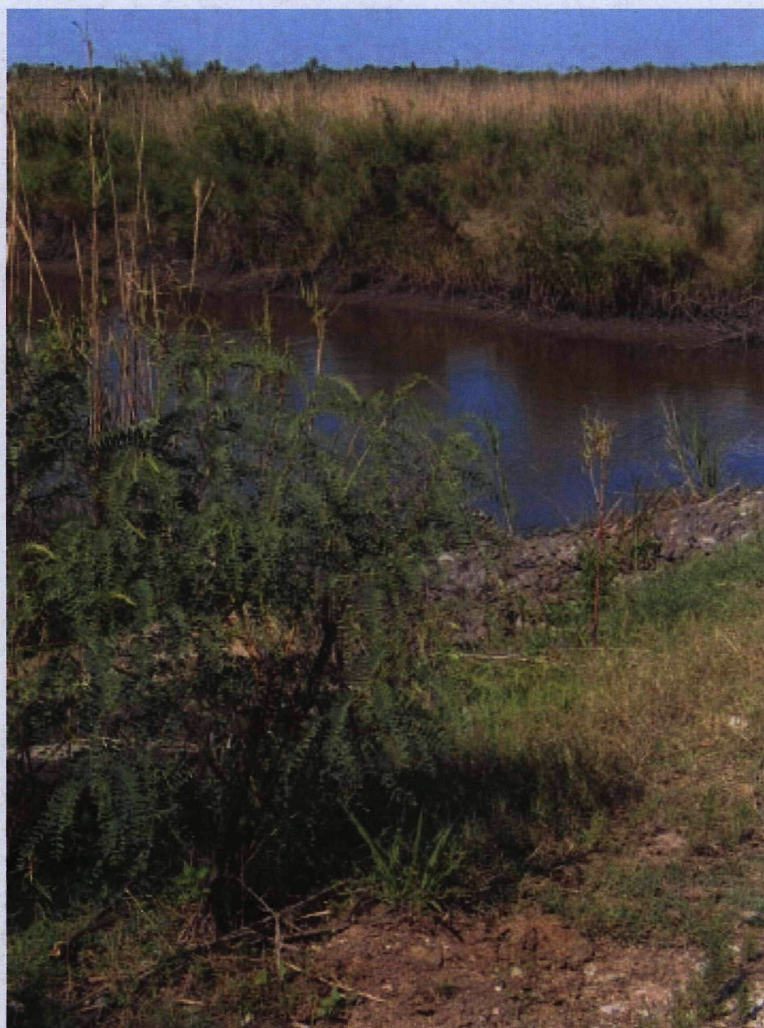
Photo 9 – New soil where culvert was removed (south side of road)

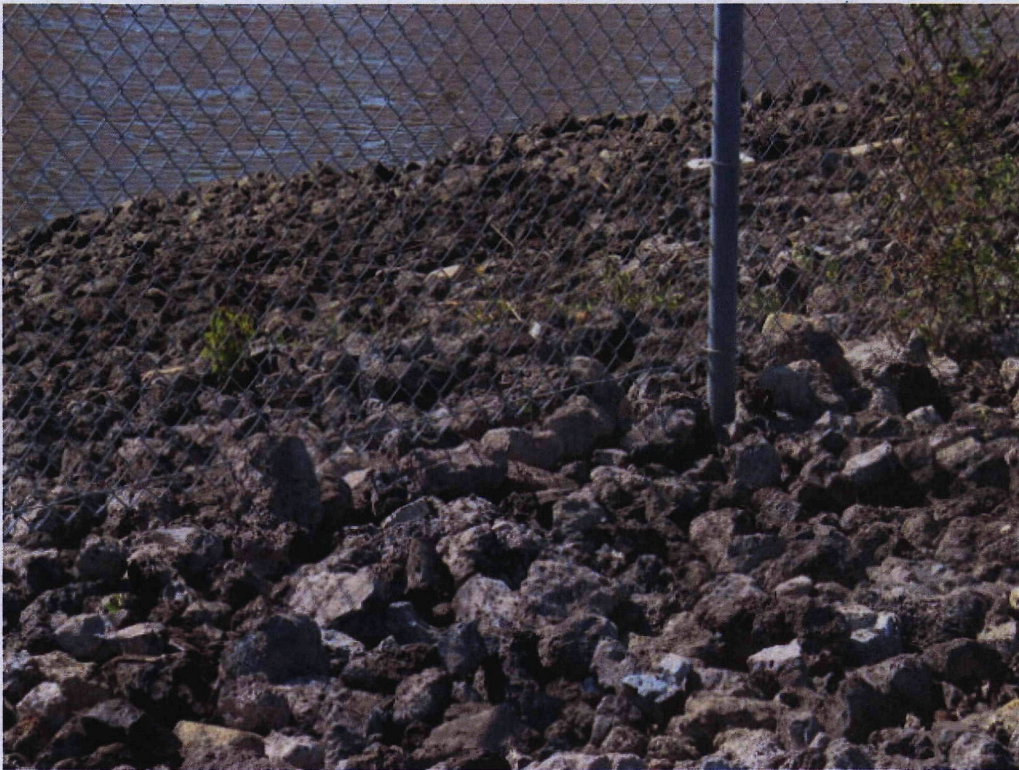
The rip rap along the East Cap that previously shifted after Hurricane Rita last year has been raked (Photo 10) so that there is no longer a gap between the rip rap and the perimeter fence.

Photo 10 – Raked rip rap along East Dike Cap (no gaps between fence and rip rap)
